**Flood Control Project Maintenance
Levee Inspections**

Fall 2016 Levee Maintenance Deficiency Summary Report

San Joaquin River Basin

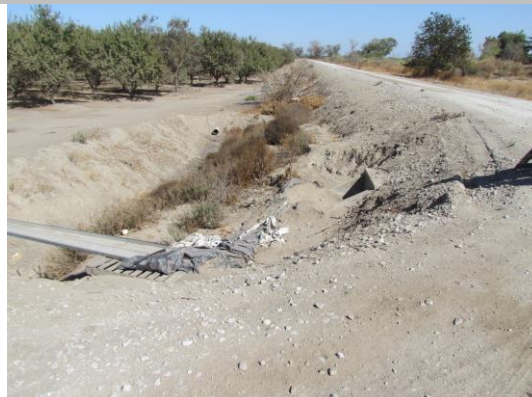
Photo 1 of 1 : FA_2016_NA0011_142_18_20161010_00023.jpg

LM Start	0.03	Rating **	U	Issue No.	18
LM End	0.06	Issue Type +	En	Location *	LS
Category	Earthen Levee			GPS Latitude/Longitude	
				Start	End
Item	Encroachments			37.046566 °	37.046715 °
				-120.427512 °	-120.426964 °
DWR ID	DWR_NA0011_01_s_2014_18				
Comment Code					
DT : Ditch					
Inspector Comment					
There seem to be lots of activity going on at this location. This ditch will cause more damage to the levee slope and toe.

Ash Slough looking upstream from the landside slope levee mile 0.03.

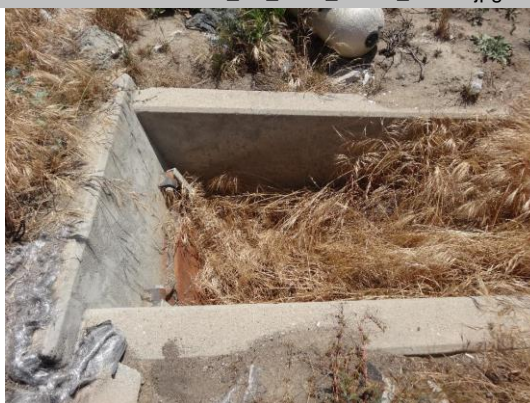
Photo 2 of 2 : UCIP_FA_2016_49976_69673.jpg

FS_ID:49976
DS_ID:21513
EP_NO: N/A
Repair Type: Urgent
Crossing Status: Found
UCIP Comments: 7/14/2016 No inspection completed--need to inspect October 2016. (DWR UCIP - omagana)5/06/2014 Landward slope has been excavated and a berm built in front of landward headwall. Sediment visible inside pipe from landward side. Dense vegetation limits the inspector's visibility to identify signs of pipe failure (leaks) along the waterward slope. Recommend removing vegetation along pipe alignment and waterward headwall to conduct proper inspection of structure. (DWR UCIP - omagana)
FIELD_STRUCT_DESC: 30-inch corrugated metal drainage pipe through the levee, 9.5 feet below the crown. Headwalls and wingwalls are located on both waterside (WS) and landside (LS) ends. Flap gate is located on the WS end. [Additional Reference(s): DWR Levee Log, 2005]
FS Date: 7/14/2016

Flap gate located on WS blocked by dense vegetation.

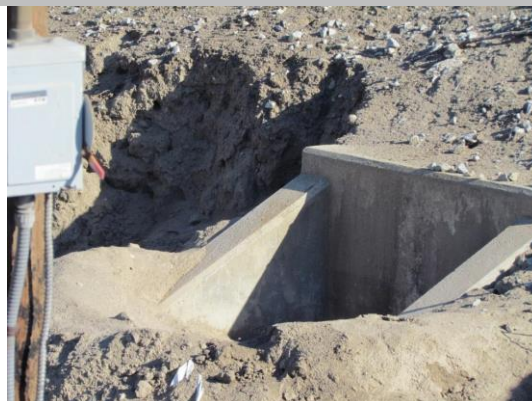
Photo 1 of 1 : FA_2016_NA0011_142_20_20160908_00004.jpg

LM Start	0.04	Rating **	U	Issue No.	20
LM End	0.05	Issue Type +	Ma	Location *	LS
Category	Earthen Levee			GPS Latitude/Longitude	
				Start	End
Item	Slope Stability			37.046624 °	37.046682 °
				-120.427317 °	-120.427108 °
DWR ID	DWR_NA0011_01_s_2014_20				
Comment Code					
S1 : Repair slope instability.					
Inspector Comment					
This is not a new erosion site, it should be repaired before the condition get any worse.

There is damage to the landside slope near the concrete wing wall.

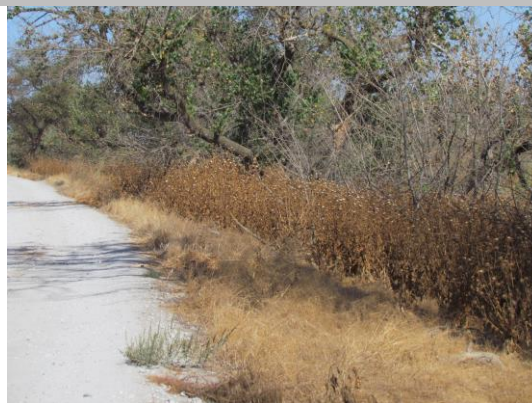
Photo 1 of 1 : FA_2016_NA0011_142_23_20161010_00024.jpg

Unit 1 Waterside looking upstream from levee mile 0.28 to levee mile 1.35.

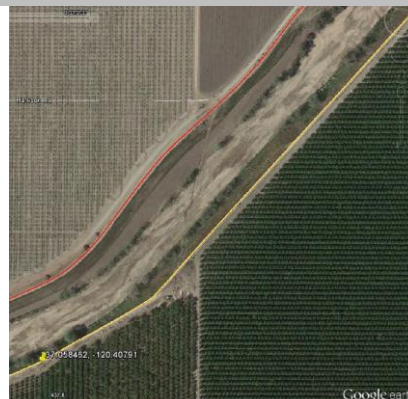
Photo 1 of 2 : UCIP_FA_2016_50057_75206.jpg

FS_ID:50057
DS_ID:25456
EP_NO: N/A
Repair Type: Urgent
Crossing Status: Found
UCIP Comments: 7/14/2016 Open pipe still remains on WS through short levee. Need to contact owner to determine extent of work completed through section of levee. (DWR UCIP - omagana)6/14/2016 Levee disturbed without prior authorization, it appears that the pipe owner did not notify CVFPB of the construction activity. Crossing was added to UCIP database. Spoke to Herman Phillips (DWR Levee Inspector) regarding unauthorized pipe installation along LS toe of U2. The LS toe of U2 (approximately 731 feet) was disturbed. DWR Inspector mentioned that Dario Dominguez with Madera County Flood Control, LMA representative, has sent the pipe owner notification of unauthorized excavation to replace existing pipe along U2 LS toe, dated May 5, 2016. After reviewing the timed aerial photographs (aerials) under Google Earth a new discovery was made regarding the extend of the area disturbed. Based on the aerials it appears that the new pipe system goes through U1 and U2 levees, across Ash Slough, and along LS toe of U2. The pipe through the levees and channel appears to tie into the work currently being done on the LS toe of U2. Both U1 and U2 levees appear to have been disturbed during 2014-2015. The aerials show that the crossing was not present in the aerial dated 4/5/2014, crossing was not present during the 2014 UCIP Inspection dated 5/6/2014, and the crossing was present in the aerial dated 3/18/2015. According to DWR Inspector, Dario Dominguez with Madera County Flood Control was notified of the additional unauthorized encroachment issue (unauthorized work completed in 2014-2015 on both levees and the channel) that could be related to the trench work being completed by Mr. Sterling. (DWR UCIP - omagana) FIELD_STRUCT_DESC: "ILLEGAL ENCROACHMENT" 10-inch to 12-inch irrigation pipe of unknown material through the levee, at an unknown depth below the crown. Pipe goes through both levees and across channel. The pipe starts on landside (LS) toe of Unit 1 (U1) and continues across channel and through Unit 2 (U2), the pipe then runs along the landside toe of U2 for approximately 731 feet. Owner of this crossing has been identified as Mr. Michael Alexander Sterling, 19140 Farallon Road, Madera, CA 93638-0313.

Aerial photo of Encroachment visible through levee and channel in 2015.
(Source: Google Earth, 3/18/2015)

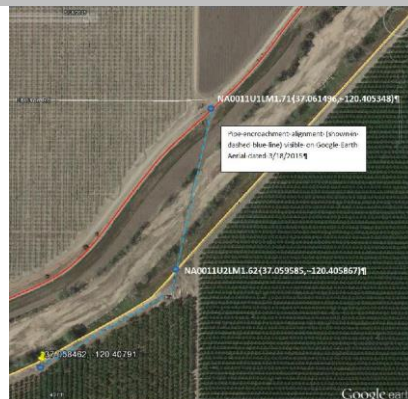
Photo 2 of 2 : UCIP_FA_2016_50057_75221.jpg

FS_ID:50057
DS_ID:25456
EP_NO: N/A
Repair Type: Urgent
Crossing Status: Found
UCIP Comments: 7/14/2016 Open pipe still remains on WS through short levee. Need to contact owner to determine extent of work completed through section of levee. (DWR UCIP - omagana)6/14/2016 Levee disturbed without prior authorization, it appears that the pipe owner did not notify CVFPB of the construction activity. Crossing was added to UCIP database. Spoke to Herman Phillips (DWR Levee Inspector) regarding unauthorized pipe installation along LS toe of U2. The LS toe of U2 (approximately 731 feet) was disturbed. DWR Inspector mentioned that Dario Dominguez with Madera County Flood Control, LMA representative, has sent the pipe owner notification of unauthorized excavation to replace existing pipe along U2 LS toe, dated May 5, 2016. After reviewing the timed aerial photographs (aerials) under Google Earth a new discovery was made regarding the extend of the area disturbed. Based on the aerials it appears that the new pipe system goes through U1 and U2 levees, across Ash Slough, and along LS toe of U2. The pipe through the levees and channel appears to tie into the work currently being done on the LS toe of U2. Both U1 and U2 levees appear to have been disturbed during 2014-2015. The aerials show that the crossing was not present in the aerial dated 4/5/2014, crossing was not present during the 2014 UCIP Inspection dated 5/6/2014, and the crossing was present in the aerial dated 3/18/2015. According to DWR Inspector, Dario Dominguez with Madera County Flood Control was notified of the additional unauthorized encroachment issue (unauthorized work completed in 2014-2015 on both levees and the channel) that could be related to the trench work being completed by Mr. Sterling. (DWR UCIP - omagana) FIELD_STRUCT_DESC: "ILLEGAL ENCROACHMENT" 10-inch to 12-inch irrigation pipe of unknown material through the levee, at an unknown depth below the crown. Pipe goes through both levees and across channel. The pipe starts on landside (LS) toe of Unit 1 (U1) and continues across channel and through Unit 2 (U2), the pipe then runs along the landside toe of U2 for approximately 731 feet. Owner of this crossing has been identified as Mr. Michael Alexander Sterling, 19140 Faralton Road, Madera, CA 93638-0313.

Assumed alignment of pipe through the levees and along LS toe of U2.
(Source: Google Earth, 3/18/2015)

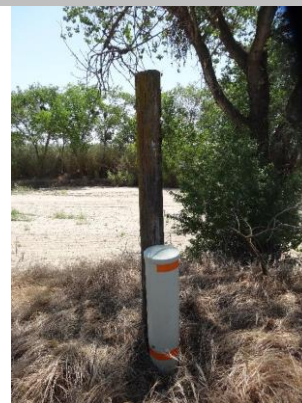
Photo 1 of 1 : UCIP_FA_2016_39846_71806.jpg

LM Start	2.09	Rating **	M	Issue No.	47
LM End	2.09	Issue Type +	En	Location *	WS
Category	Supplemental			GPS Latitude/Longitude	
				Start	End
Item	DWR UCIP Field Study			37.065569 °	37.065569 °
				-120.400752 °	-120.400752 °
DWR ID					
Comment Code					
Inspector Comment					
FS_ID:39846					
DS_ID:21511					
EP_NO: N/A					
Repair Type: Non-Urgent					
Crossing Status: Indicator Found					
UCIP Comments: Need to contact to owner to get contact information.					
FIELD_STRUCT_DESC: Underground telephone cable crosses through levee.					
FS Date: 5/6/2014

Conduit box located on waterward side.

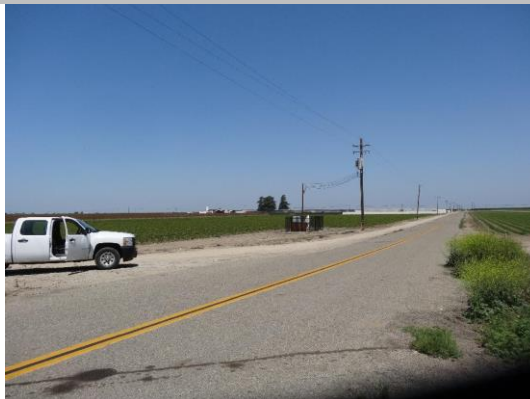
Photo 1 of 2 : UCIP_FA_2016_39845_71800.jpg

LM Start	2.10	Rating **	M	Issue No.	46
LM End	2.10	Issue Type +	En	Location *	WS
Category	Supplemental			GPS Latitude/Longitude	
				Start	End
Item	DWR UCIP Field Study			37.065649 °	37.065649 °
				-120.400663 °	-120.400663 °
DWR ID					
Comment Code					
Inspector Comment					
FS_ID:39845 DS_ID:25042 EP_NO: N/A Repair Type: Non-Urgent Crossing Status: Found UCIP Comments: Need to contact owner to determine if crossing goes through levee. FIELD_STRUCT_DESC: 10-inch or 12-inch pipe through levee crossing visible inside concrete standpipe on waterward side. Potential pump station located on landward side approximately 100 feet from standpipe. FS Date: 5/6/2014

Pump station visible approximately 100 feet from concrete standpipe.

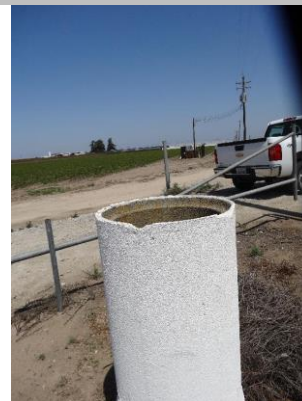
Photo 2 of 2 : UCIP_FA_2016_39845_71803.jpg

Standpipe visible on waterward side.

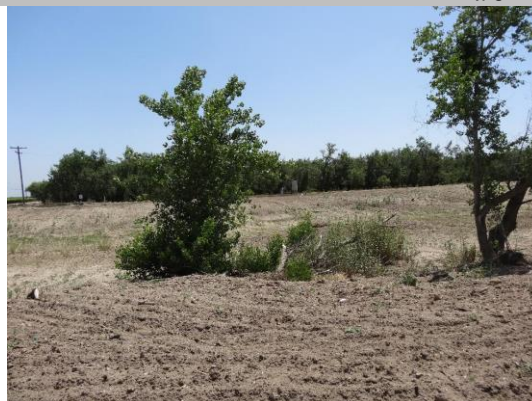
Photo 1 of 2 : UCIP_FA_2016_38226_69679.jpg

LM Start	2.37	Rating **	M	Issue No.	45
LM End	2.37	Issue Type +	En	Location *	WS
Category	Supplemental			GPS Latitude/Longitude	
				Start	End
Item	DWR UCIP Field Study			37.068763 °	37.068763 °
				-120.398523 °	-120.398523 °
DWR ID					
Comment Code					
Inspector Comment					
FS_ID:38226					
DS_ID:21512					
EP_NO: N/A					
Repair Type: Non-Urgent					
Crossing Status: Found					
UCIP Comments: Unable to determine details of crossing and whether crossing has been abandoned. Need to find owner and determine the alignment of crossing to confirm if pipe is being extended from opposite levee.					
FIELD_STRUCT_DESC: Abandoned service pole, pump and two 36-inch standpipes on landward side. Pump not found in 2014 inspection. Three stand pipes found on landward side.					
FS Date: 5/6/2014

View of waterward side.

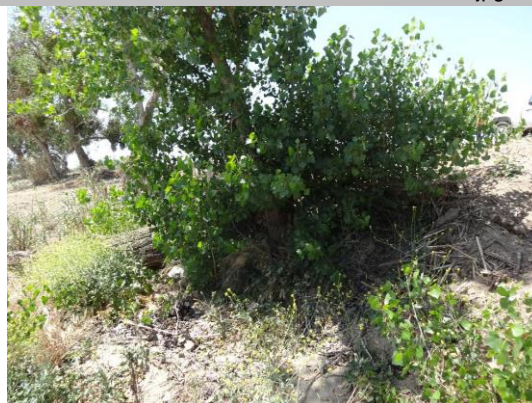
Photo 2 of 2 : UCIP_FA_2016_38226_69678.jpg

View of waterward slope--no signs of crossing visible.

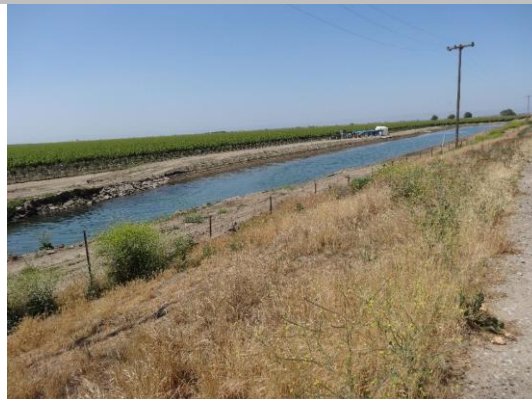
Photo 1 of 2 : UCIP_FA_2016_39686_71662.jpg

LM Start	0.01	Rating **	M	Issue No.	48
LM End	0.01	Issue Type +	En	Location *	WS
Category	Supplemental			GPS Latitude/Longitude	
				Start	End
Item	DWR UCIP Field Study			37.045532 °	37.045532 °
				-120.427268 °	-120.427268 °
DWR ID					
Comment Code					
Inspector Comment					
FS_ID:39686					
DS_ID:21585					
EP_NO: 8068					
Repair Type: Non-Urgent					
Crossing Status: Found					
UCIP Comments: Unable to confirm if crossing found in the field corresponds to the crossing described under Permit 8068. Only 1 crossing found permit indicates 2 irrigation culverst. Need to contact owner to obtain additional details of crossing.					
FIELD_STRUCT_DESC: To retain two irrigation culverts and siphons located at the intersection of Ash Slough and the Chowchilla Canal.					
FS Date: 5/6/2014

View of landward side.

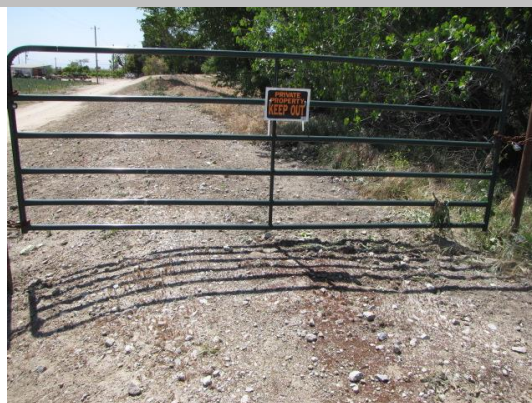
Photo 1 of 1 : FA_2016_NA0011_143_5_20161004_00003.jpg

LM Start	0.18	Rating **	M	Issue No.	5
LM End	0.31	Issue Type +	En	Location *	CR
Category	Earthen Levee			GPS Latitude/Longitude	
				Start	End
Item	Encroachments			37.046315 °	37.463150 °
				-120.424419 °	-120.424419 °
DWR ID	DWR_NA0011_02_f_2012_5				
Comment Code					
FE : Fence					
Inspector Comment					
This fence was not authorized by CVFPB. The District is aware of the fence. The landowner installed the fence and gate across the levee section because he has been broken into frequently and had many items stolen in the past. I met with the landowner 4-29-2014 and he let me put a State lock on his gate to gain access to the levee.

Unauthorized gate and metal fence placed on slope and toe of levee section. Photo taken 4-17-2013.

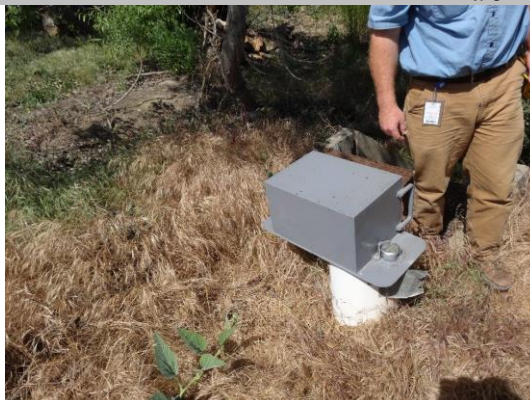
Photo 2 of 2 : UCIP_FA_2016_35764_64466.jpg

Locked box (unknown purpose) located on waterward side.

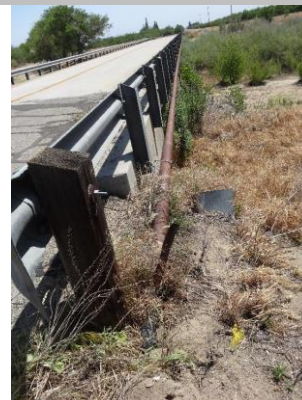
Photo 2 of 2 : UCIP_FA_2016_39923_71822.jpg

View of steel conduit through levee and above channel.

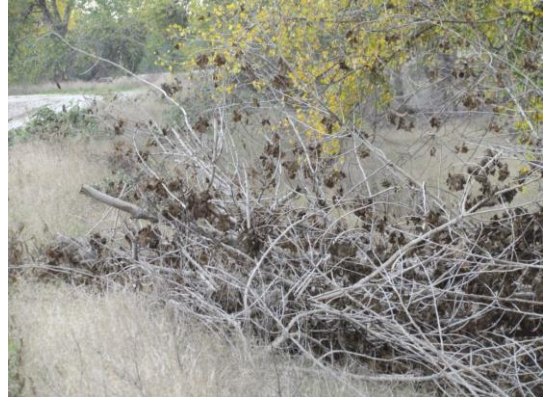
Photo 1 of 1 : FA_2016_NA0011_143_43_20161004_00008.jpg

Unit 2 levee mile 1.46-1.49 looking upstream from the levee slope
waterside fallen dead tree on the levee section.

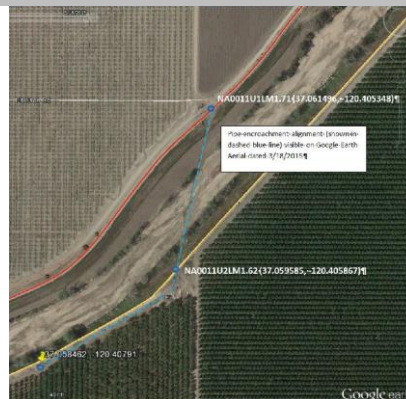
Photo 1 of 2 : UCIP_FA_2016_49978_75220.jpg

Assumed alignment of pipe through the levees and along LS toe of Unit 2. (Source: Google Earth, 3/18/2015)

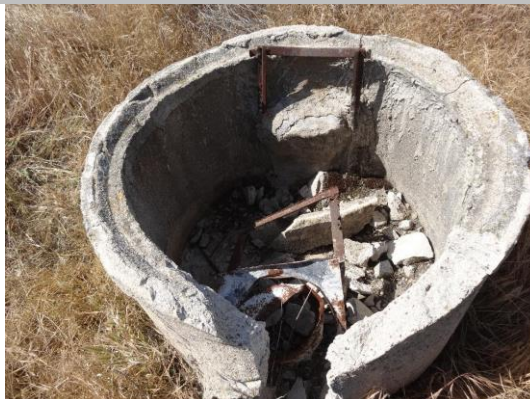
Photo 2 of 2 : UCIP_FA_2016_39925_71820.jpg

36-inch pipe full of concrete debris located on waterward side.

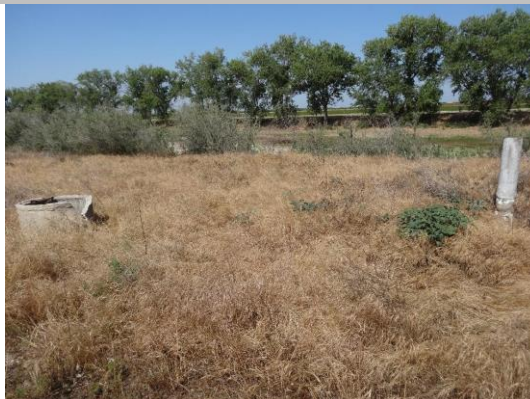
Photo 2 of 2 : UCIP_FA_2016_39924_71808.jpg

Concrete standpipes visible on waterward side--dense vegetation on waterward side.

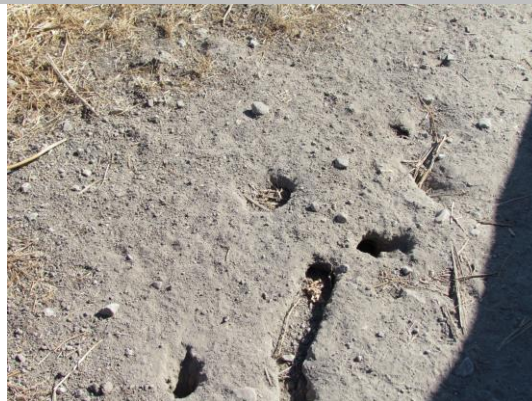
Photo 2 of 2 : FA_2016_NA0011_144_6_20161011_00018.jpg

More active rodents holes and foot traffic seen around holes though no rodents observed.

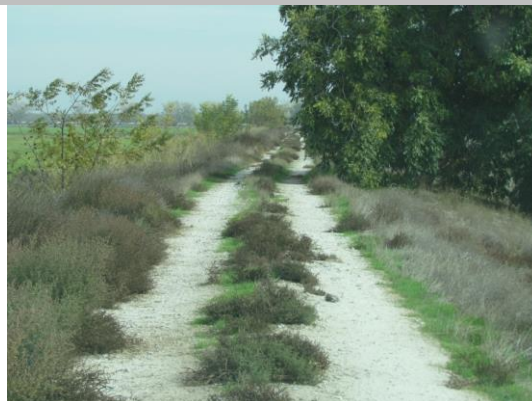
Photo 1 of 1 : FA_2016_NA0011_144_44_20161004_00008.jpg

Looking upstream from levee mile 1.04 to levee mile 1.52 crown roadway overgrown with tall weeds.

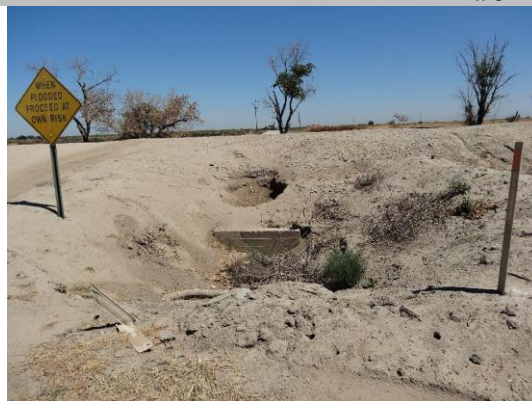
Photo 2 of 2 : UCIP_FA_2016_49977_75761.jpg

Sink hole and concrete headwall damage is visible on LS.

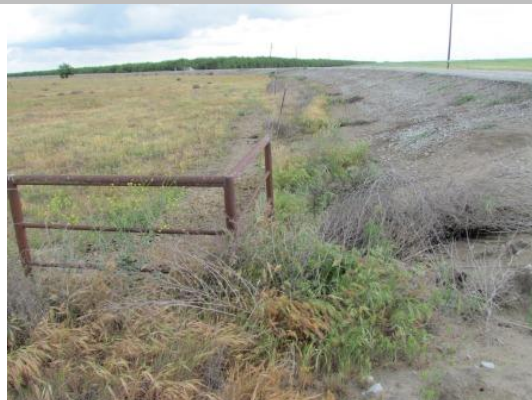
Photo 1 of 1 : FA_2016_NA0011_145_56_20161004_00011.jpg

Fence within the 10-foot of levee toe. This encroachment was recorded on 11-01-2012. Photo was taken 4-24-2014.

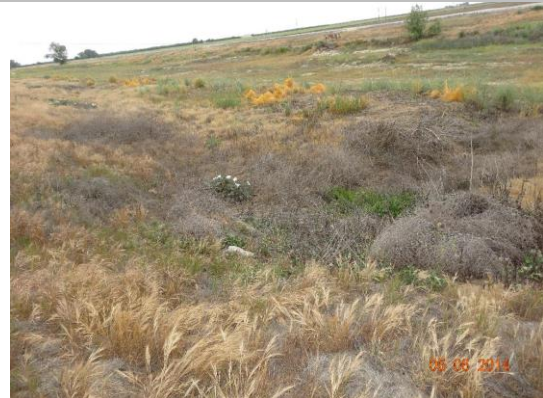
Photo 2 of 2 : UCIP_FA_2016_39006_69714.jpg

Concrete headwall covered by dense vegetation.

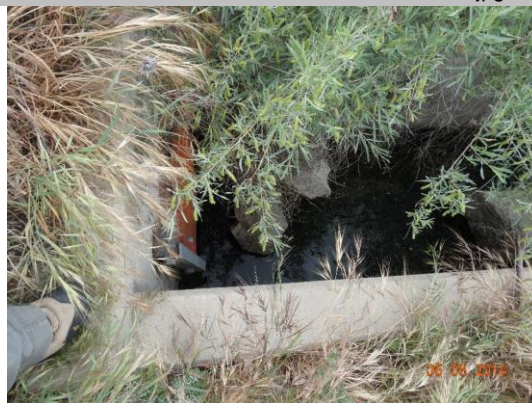
Photo 2 of 2 : UCIP_FA_2016_38235_69721.jpg

Concrete headwall visible on waterward side and covered by dense vegetation.

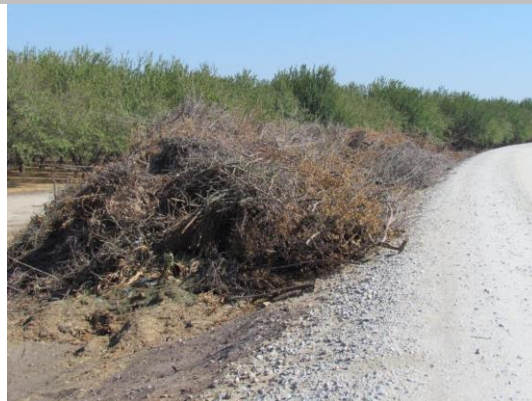
Photo 1 of 1 : FA_2016_NA0011_146_35_20161004_00006.jpg

Looking upstream at hugh pile of almond tree cuttings covering the landside shoulder,slope and toe.

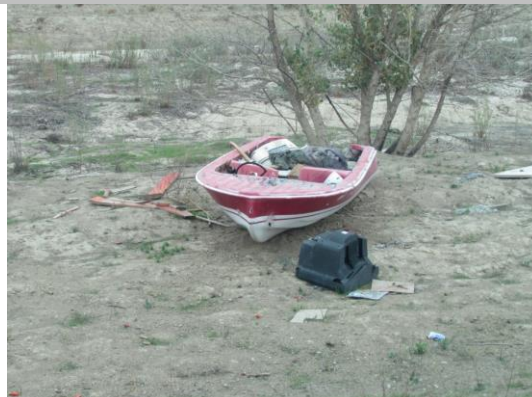
Photo 1 of 1 : FA_2016_NA0011_147_46_20161004_00008.jpg

Waterside levee mile 0.51 abandoned boat. Busted tv and other trash dumped on the dry channel.

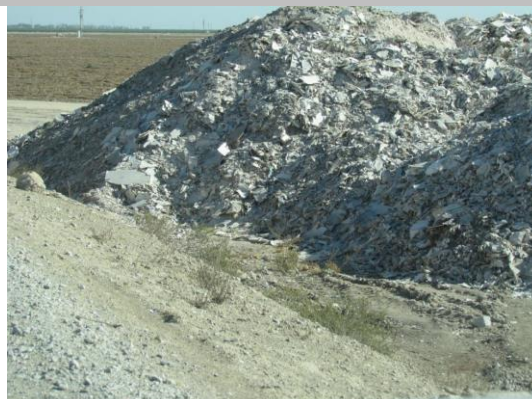
Photo 1 of 1 : FA_2016_NA0011_147_1_20161004_00001.jpg

Recycle sheet rock piles within the landside easement.
